ATC[®]
AUTOTOP CO., LTD.

WATER PUMP

PRODUCTS LIST

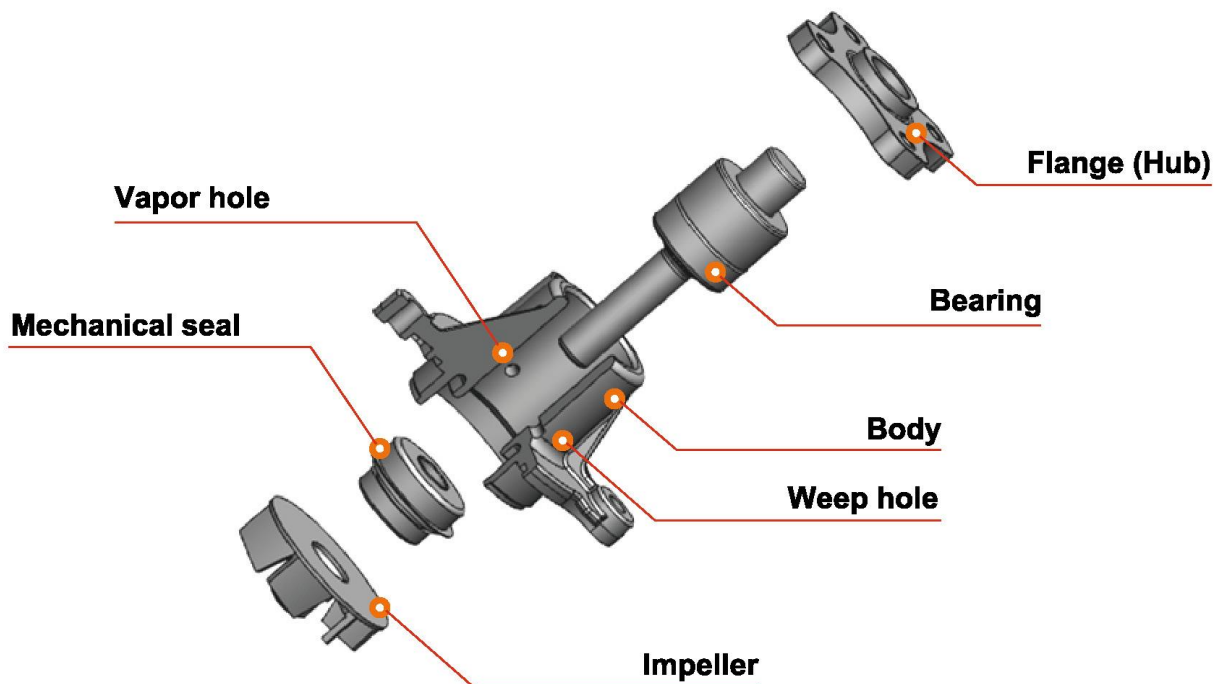
- A water pump consists of flange (Hub), bearing, body, mechanical seal, impeller, etc.
- The power of the rotating crank shaft rotates the bearing shaft and the impeller through the timing belt and the water pump pulley.
- The coolant of the engine water pump rotates together by the impeller and circulates back and forth to the engine water jacket and the radiator by the action of centrifugal force.
- The water pump body has a vapor hole and a weep hole.
The vapor hole emits excess gas pressure that permeates in through mechanical seals.
The weep hole discharges the coolant that leaks out through mechanical seals.
These two holes function to protect the shaft and the bearings from contamination.

- Flange (Hub) is equipped with a pulley or pen clutch.
- Bearing is pressed into the water pump body.
There are Ball / Ball and Ball /Roller types.
- Body is aluminum, with Die-Cast, Gravity-Cast and Cast-Iron.
- Mechanical seals prevent the leakage of coolant.
- Impellers are available in pressed steel, cast iron or resin types.

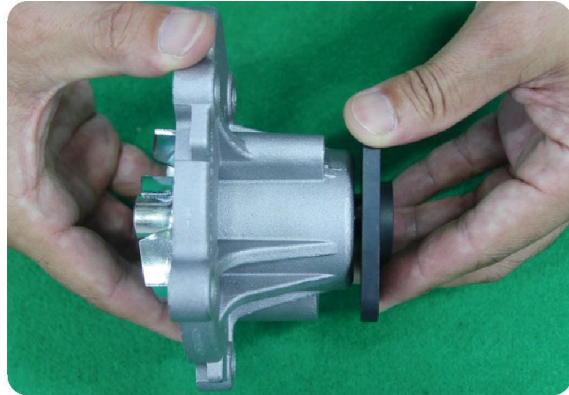
1 Do not dry turn the flange (Hub)

Do not turn the flange manually before installing the water pump.
Turning it in a dry state can damage the carbon and cause a squeaky sound.
It can make a squeaky sound when it is dry, but the sound stops when the water pump is mounted on the engine and coolant is supplied on the contact surface of the mechanical seal.

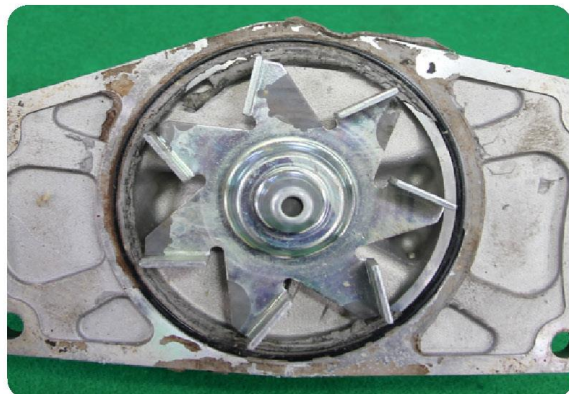
3 Use only an appropriate amount of liquid sealant

Do not use too much liquid sealant when installing the water pump.
When too much liquid sealant is applied it will float on the coolant and penetrate between the carbon and ceramic of the mechanical seal, causing leakage in a short period of time.

Evenly apply an appropriate amount of liquid sealant on both sides of the new gasket. Do not apply liquid sealant to O-rings or metal gaskets. Excessive use of liquid sealant may cause leakage in a short period of time.

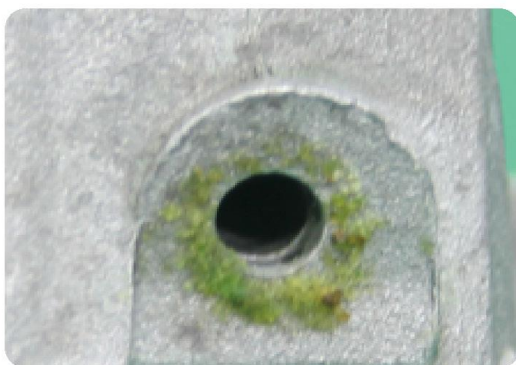
Traces of dried coolant are normal.

- The weep hole prevents corrosion to the bearings caused by coolant leaking from the mechanical seals.
- Traces of dried coolant around the weep hole are normal. If there is wet coolant around the weep hole or the water level of the coolant storage tank drops within a short period of time, there may be a coolant leak.

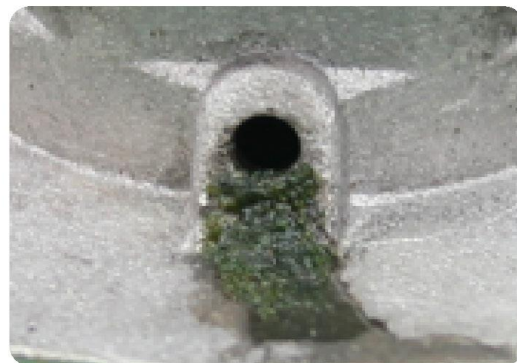
If the surroundings are wet or water flows, the engine is damaged.

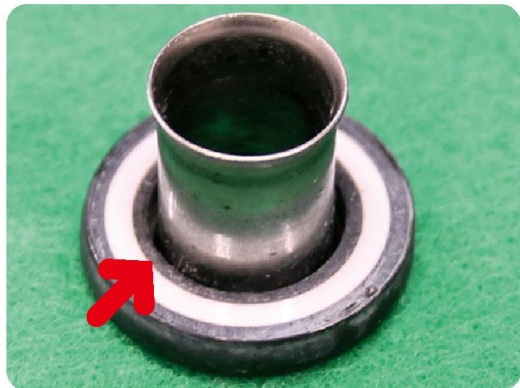
Sludge has accumulated due to contaminated coolant.

- The mechanical seal is damaged or its performance is degraded due to contamination and sludge in the coolant.

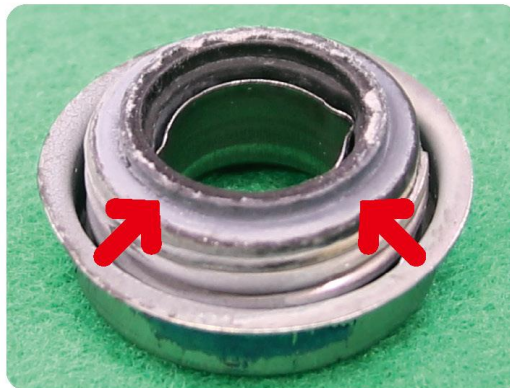
Rust or foreign substances floating in the coolant have penetrated and adhered.

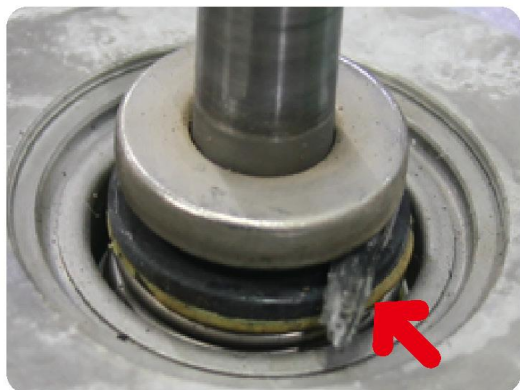
liquid sealant has penetrated into the mechanical seal.

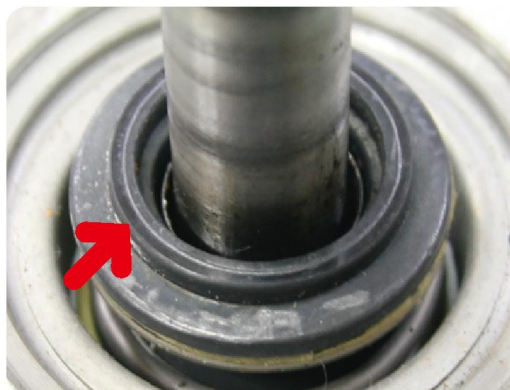
Hard foreign substances in the coolant have penetrated into the seal, and the carbon has become worn out.

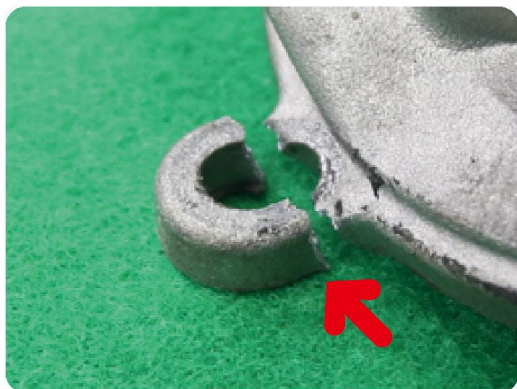
The body was damaged by using an air tool to fasten the bolt.

- Foreign substances remaining on the mounting surface of the water pump, such as gasket, rust, scale, etc. were not removed completely.
- The gasket has been damaged or deformed.
- The liquid sealant was not applied.
- There is a dent in the gasket joint due to careless handling.
- Using the wrong liquid sealant may degrade the sealing function.
- Using air tools to fasten bolts may damage the body or cause cracks.
- For O-rings or metal gaskets, the sealing function is reduced when liquid sealants are applied.

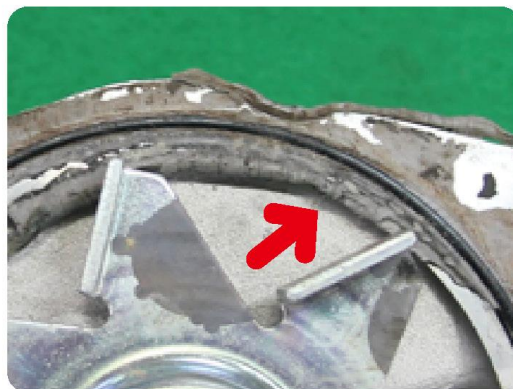
The sealing function was degraded by applying liquid sealant to the O-ring.

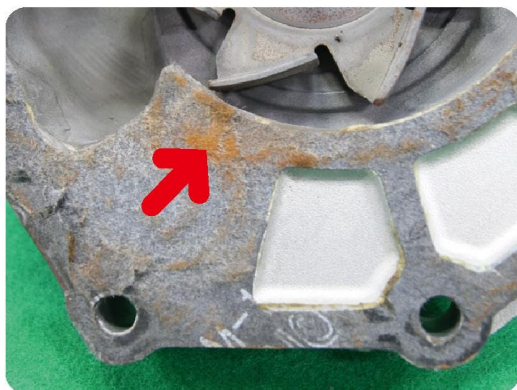
Foreign substances remaining on the mounting surface such as rust, scale, etc. were not removed completely.

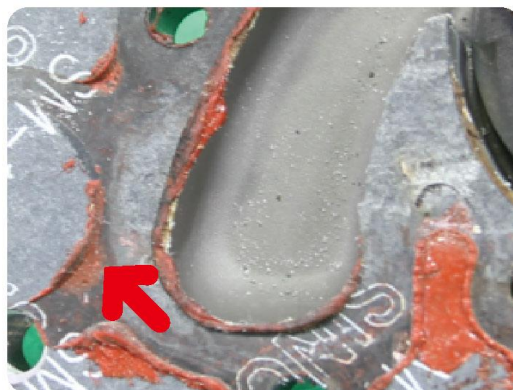
The sealing function was degraded due to excessive application of liquid sealant.

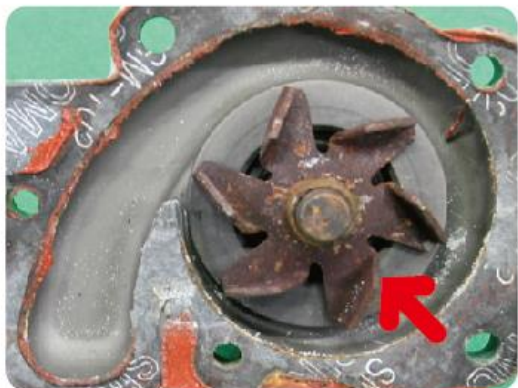
The coolant deteriorated (contaminated) and the impeller in the water pump became corroded.

- The antifreeze has become oxidized because the coolant has not been replaced for too long.
- Either the coolant is not mixed with antifreeze or the concentration of the antifreeze is insufficient.
- The coolant is frozen.
- The amount of coolant is insufficient.
- The radiator pipe is clogged.
- There is a leak in the coolant circulation pipe.

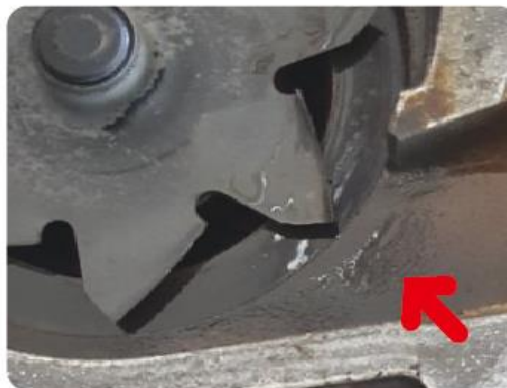
The coolant deteriorated (contaminated) and the water pump body became corroded.

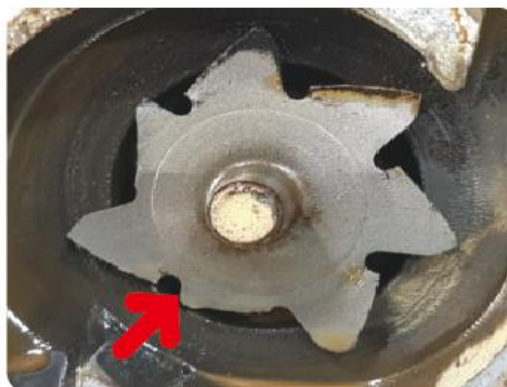
The coolant deteriorated (contaminated) and the impeller melted and disintegrated.

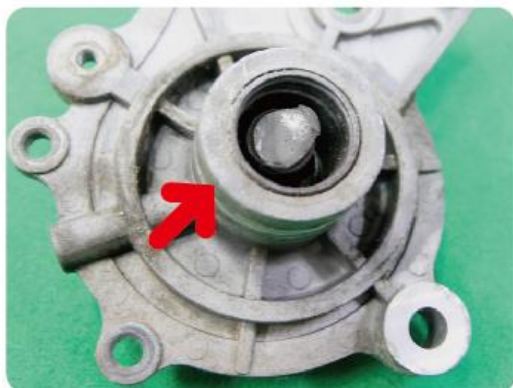
- Due to failure of the mechanical seal, coolant penetrated into the bearing and the bearing was damaged.
- Replace the coolant regularly.

- Coolant has penetrated into the bearing due to failure of the mechanical seal.
- If the fan coupling or pulley is installed incorrectly or damaged, the body or the bearing of the water pump will be damaged.
- Bearings are damaged due to excessive belt tension.
- Bolts in the fan coupling and pulley were loosened due to incorrect fastening, causing excessive vibration and damage to the bearings or the body.
- Foreign substances were not removed from the mounting surface of the fan coupling and pulley, causing excessive vibration and damage to the bearings.

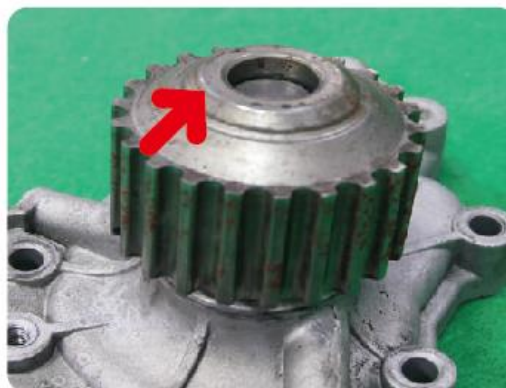
The pulley dislodged due to excessive belt tension.

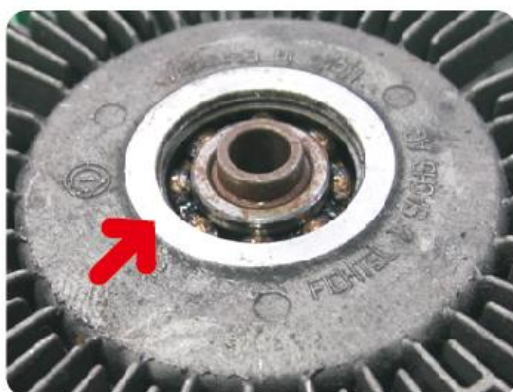
- The bearing in the fan coupling is damaged or broken. If used continuously, the body or the bearing of the water pump will be damaged.
